# INTERNAL TESTS

## Ryno SafeWaste XL

### Bin - 43kg

Sample: Ryno SafeWaste XL Bin  
Date: 20/07/2026  
Tester #1: Jonathon Drummond  
Standard: N/A

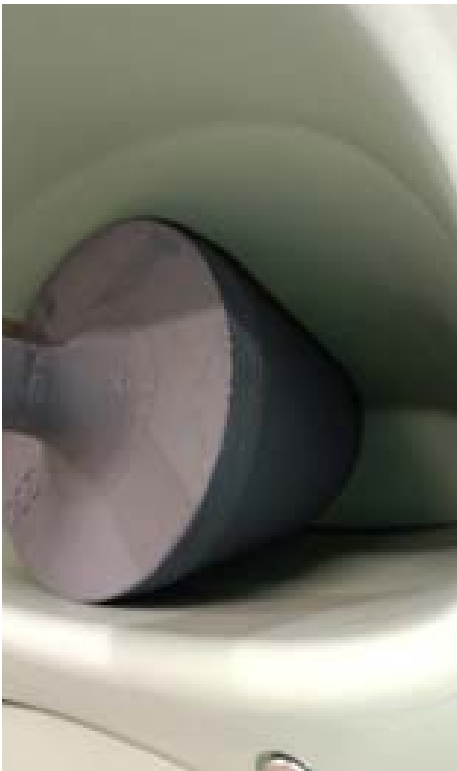
| Test Type | Photos | Comments (including pass/fail) |
|---|---|---|
| Entrapment | | <p>The entrapment test tool was able to enter the opening; however, it could be easily withdrawn without resistance or becoming trapped.</p> <p>No entrapment was observed during testing.</p> <p>-Pass</p> |

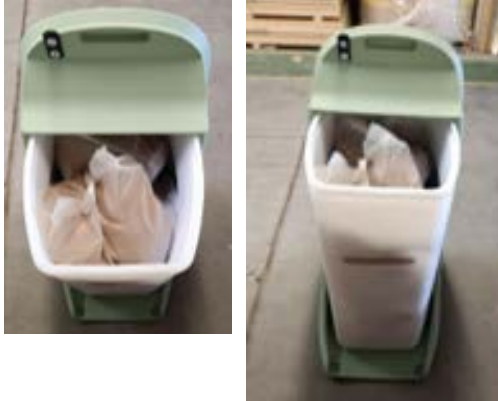
| Test Type | Photos | Comments (including pass/fail) |
|---|---|---|
| Static Load | | <p>The bin was subjected to a load of <b>110 kg</b> and successfully supported the weight without any observed issues. The wheeled trolley remained fully mobile and operational under load, with no signs of instability or impaired functionality.</p> <p>-Pass</p> |

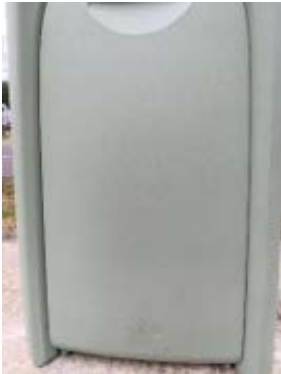
| Test Type | Photos | Comments (including pass/fail) |
|---|---|---|
| MOJ Kick Test | | <p>The bin was subjected to repeated impacts using a <b>6.4 kg</b> sledgehammer over a continuous <b>5-minute period</b>. No visible damage, cracking or structural deterioration was observed following testing.</p> <p>-Pass</p> |

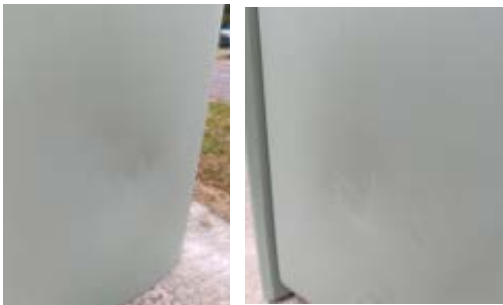
| Test Type | Photos | Comments (including pass/fail) |
|---|---|---|
| Attack Test | | <p>The bin was subjected to <b>five impacts</b> using a sledgehammer. Minor denting was observed on the side of the bin, while the door sustained only superficial scratching. No significant structural damage was observed during testing.</p> <p>-Pass</p> |
